Manhole Inspection Summary

Manhole # S19MM_011MH

Insp Date: **7/5/07 8:42 AM**

Location Address: **2224 MONROE ST**

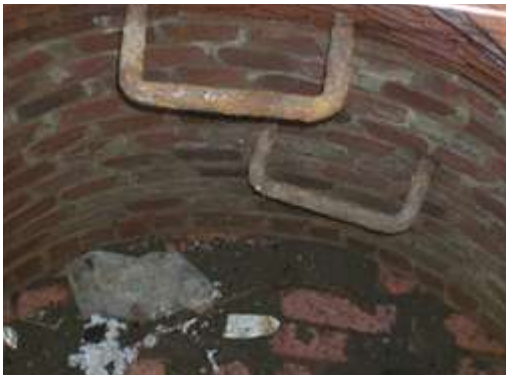
Defect 1

Steps Count: **2** Missing: **0** ☒ **Corroded**

CORRODED STEPS

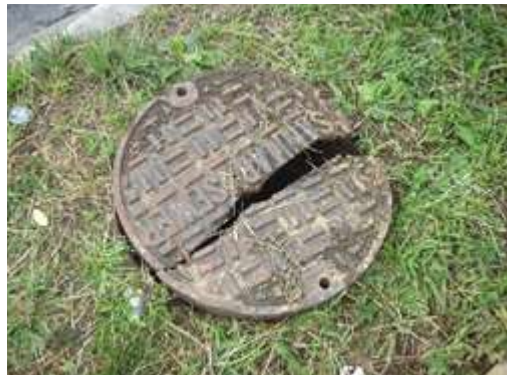
Defect 2

Comments **LID WAS BROKEN IN 2 CALLED 311. COMFERMATION NUMBER FOR 311 IS 326981**

Type: **Sanitary** Condition: **Broken** Cover Material: **Cast Iron**

BROKEN MH LID, CALLED 311
